Manhole Inspection Summary

Manhole # S39WW_010MH

Insp Date: **12/18/06 2:49 PM**

Location Address: **3001 ELLERSLIE AVE**

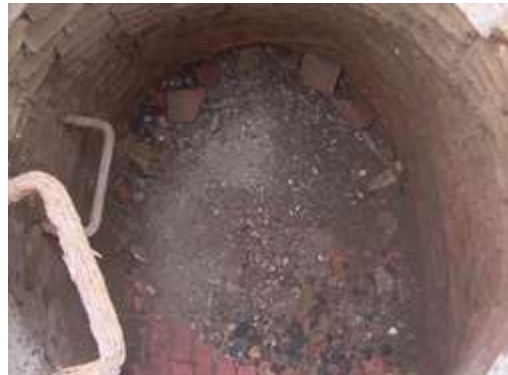
Top View

☒ **Debris** (not Condition related)

☒ **Corroded**

Corroded steps. Channel debris.

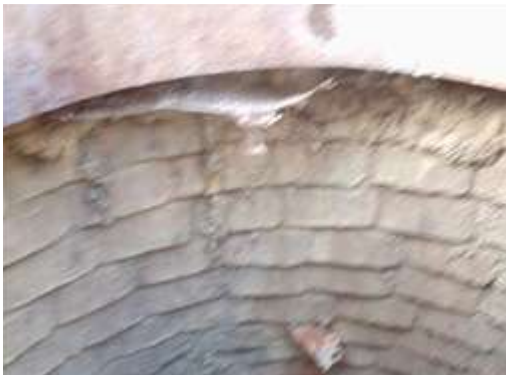
Defect

☒ **Leaks**

Condition: ☐ Sound ☐ Cracked ☐ Root Intrusion ☐ Loose Brick ☒ **Deteriorated**

Infiltration: ☐ None ☒ **Joint** ☐ Cracks ☐ Mortar ☐ Roots ☒ **Wall**

Frame leaks. Corbel deterioration and infiltration.

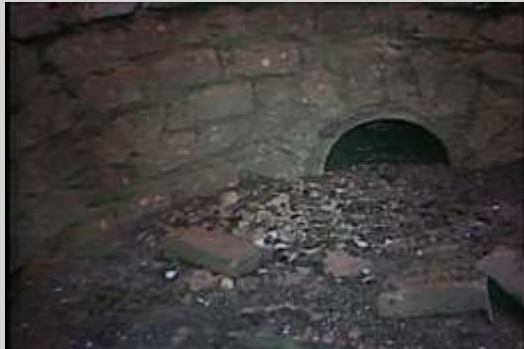
8 in. Circular Gravity Sewer
Pipe Out @ 12 O'Clock

Deposits: ☐ None ☒ **Mud** ☐ Sludge ☒ **Debris** ☐ Grease

Silt Depth: **3** (in.) Deposits Extent: **Light**

Infiltration: **Evidence** Pipe Seal Cond: **Unknown**
